Following the approval of the previous consent for listed building works ref 19/1567/LBC, these works have started to be implemented and now cleaning and vegetation has started to be removed from the Windmill Tower it has revealed further works required for a certificate of lawfulness update. Some are emergency works and some are works to protect the Windmill for the future.

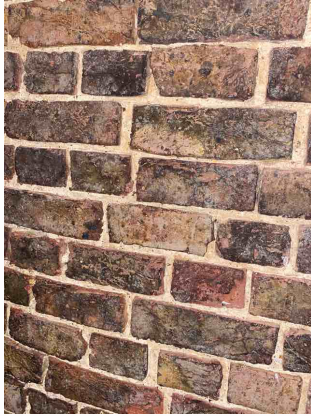
Item 1 - This is an example of the cleaned section of brickwork, following cleaning the pointing is missing / blown over the years from the 20-30mm of brickwork joints across the tower and needs to be racked out and replaced with Lime Mortar. An original sample of brickwork covered up by cladding has been found showing the flush pointing, see item 2 below.

- Works to entire tower brickwork
- Rack out lime mortar to 40mm deep.
- Install Limetec Heritage Hydraulic lime mortar Ref HMTY180- Traditional London Flush Joint
- Re pointing is to be completed in a continuous visit from top to bottom to ensure consistent finish.

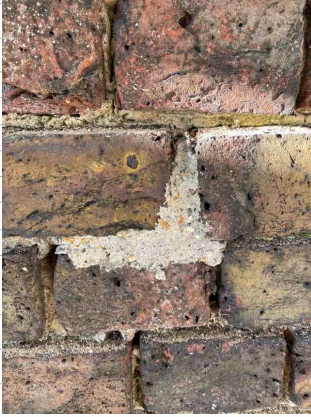
Item 5

There are various instances where cement mortar repairs have been carried out to the Tower over the years. Cement mortar is to be removed to ensure a consistent finish and as cement mortar acts different to Lime mortar this can cause further issues if not removed.

- Cement mortar removed by hand if possible
- Re pointed in Lime mortar as above items

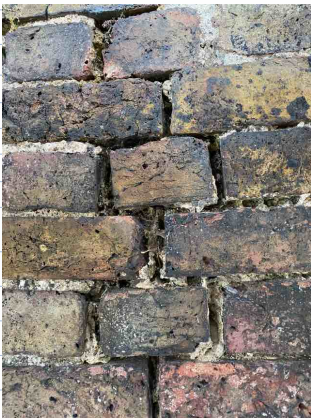
Item 6

As item 4 above, structural movement cracking has been found half way up the tower. The cracks are of a large width and the mortar is missing. As item 4 this is an emergency repair to stop any further degradation of the brickwork.

- Repair sequence as item 4.

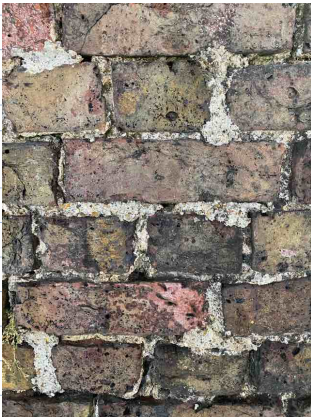
Item 7

As item 5 - further example.

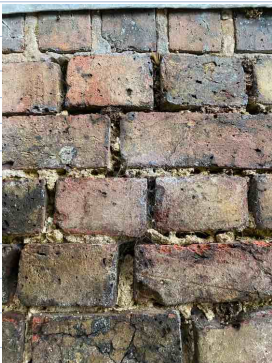
item 7

Mortar completely missing in various sections to 50mm deep into the wall.

- works to be repaired as item 1,2 and 3

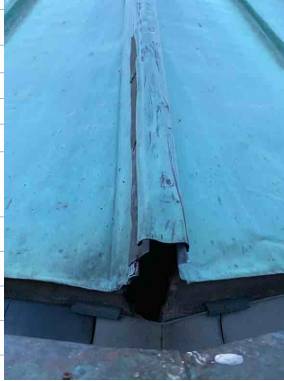
Item 9

Lead Cap roof damage which is leaking into internals of the building.
Install metal cover piece to fill hole and re crimp metal roof to ensure weather tightness
Are is not seen as behind parapet roof

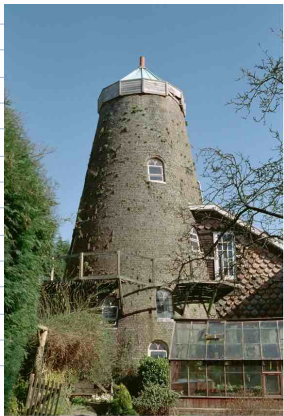
Item 10 - Photo from the Historic England Register dated 2003

Repair and reinstatement of Timber Balcony around windmill tower. This balcony is described in the Historic England listing ref 1100797 and further research has found photos below to allow reinstate the to match original. We dont believe listed building consent is required as these works are repair and reinstatement to match original and do not alter the listed building as the record includes.

- Repair and put back timber balcony into original metal sockets around the Windmill Tower
- Metal sockets remain in the brickwork facade, this sets out the shape, size and form of the balcony to go back
- Examples of the balcony arms and deck remain on site for timber sizing etc.
- Replacement balcony to be constructed from Oak and painted white to match original colour photo's shown below.

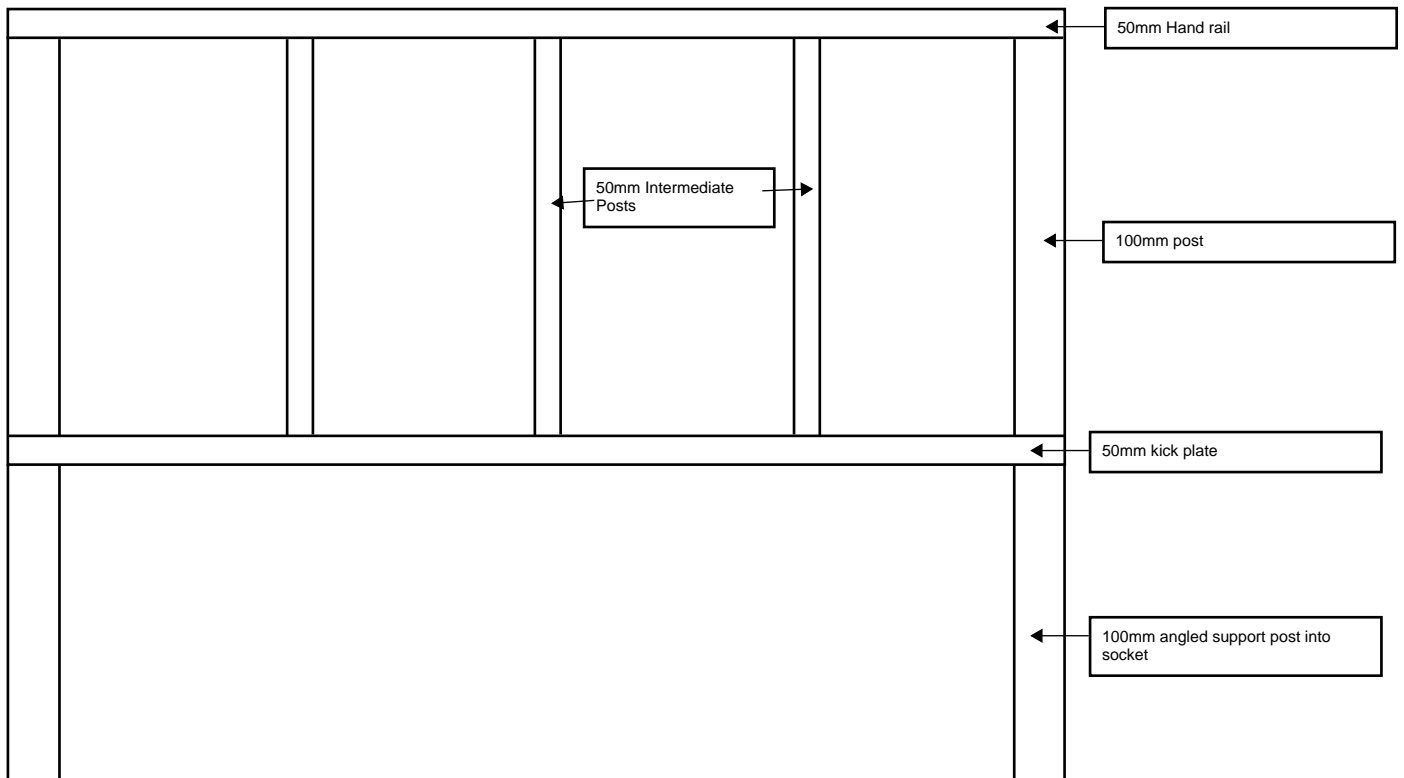
Item 10

Zoomed in section of previously issued photo for balcony bay detail.

Based on the details from photos the balustrade bay is comprised of 2nr 75mm x 75mm posts on either end of the bay. With 3nr 50mm intermediate posts in between. This is framed top and bottom by a 50mmx50mm timber hand rail and kicker plate.

The 75mm posts at either end of each bay would sit on top of the braces below which sit into the existing sockets in the brickwork. Below is a elevation drawing of each bay. This bay detail repeats around the tower to suit socket locations. The existing sockets are 75mm wide allowing us to confirm the above.
