BS5837:2012 TREE SURVEY

15A, Chorleywood Common, Chorleywood

Revised
August 2017

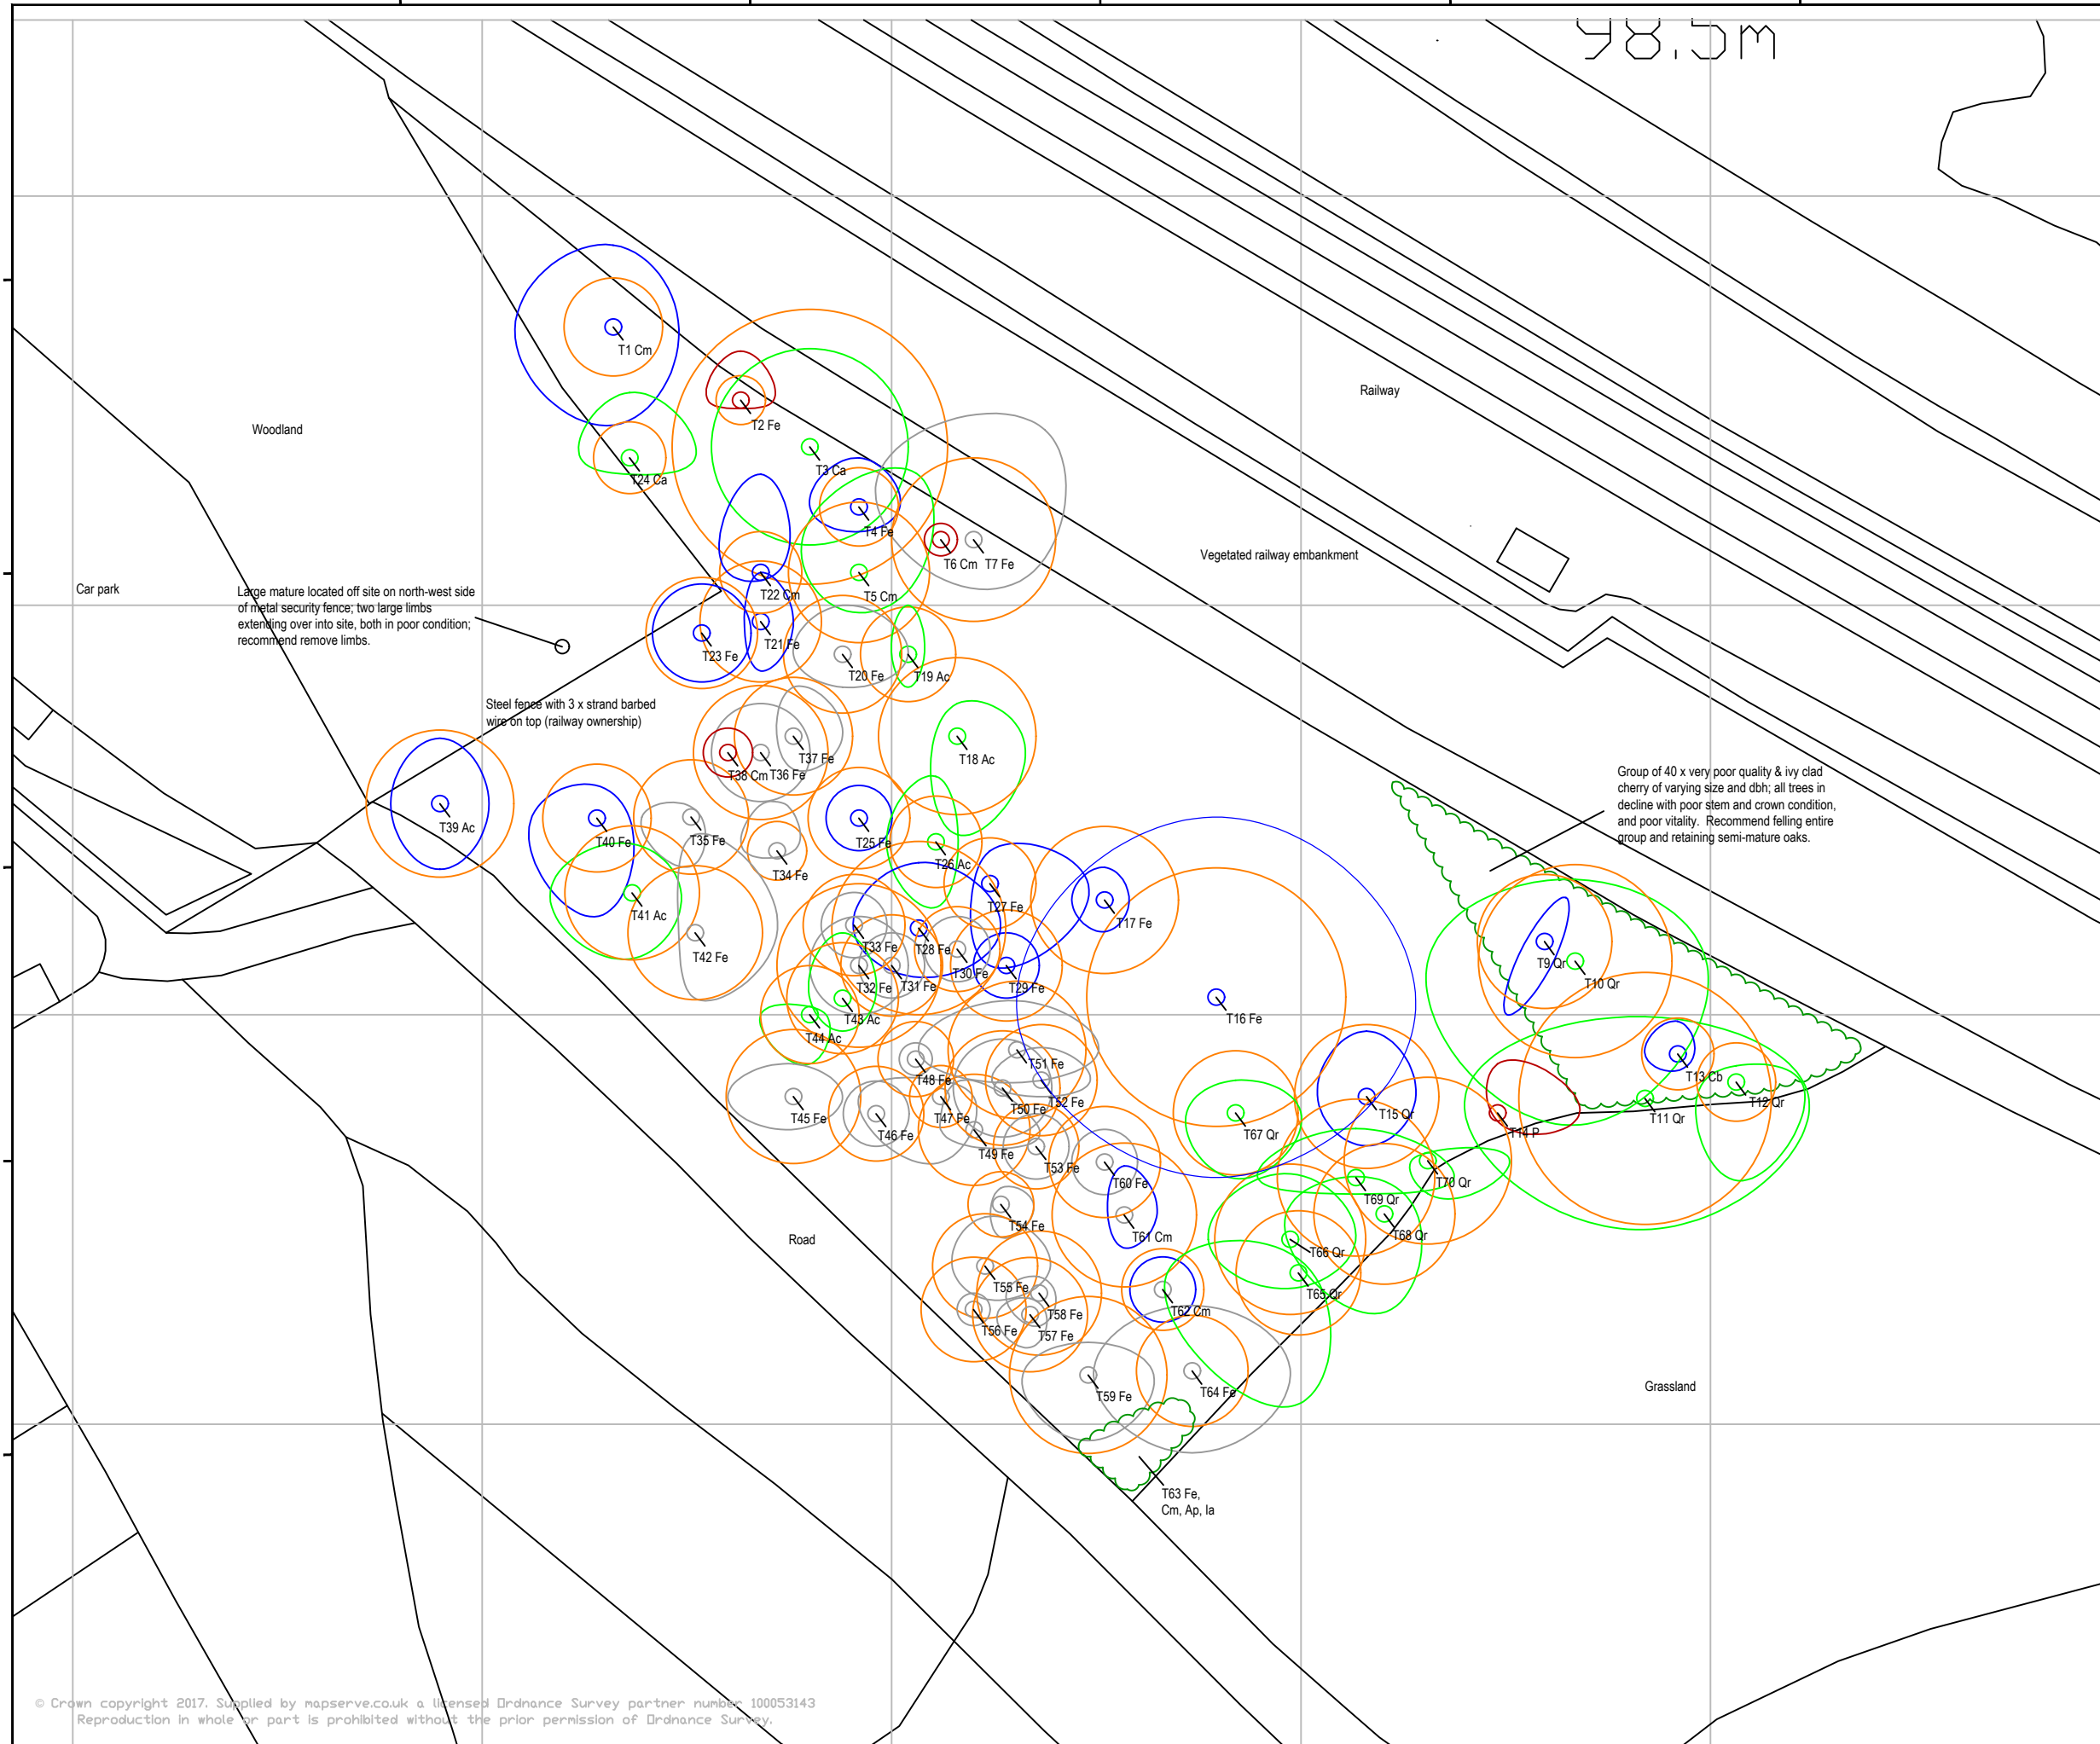
Large mature located off site on north-west side of metal security fence; two large limbs extending over into site, both in poor condition; recommend remove limbs.

Group of 40 x very poor quality & ivy clad cherry of varying size and dbh; all trees in decline with poor stem and crown condition, and poor vitality. Recommend felling entire group and retaining semi-mature oaks.

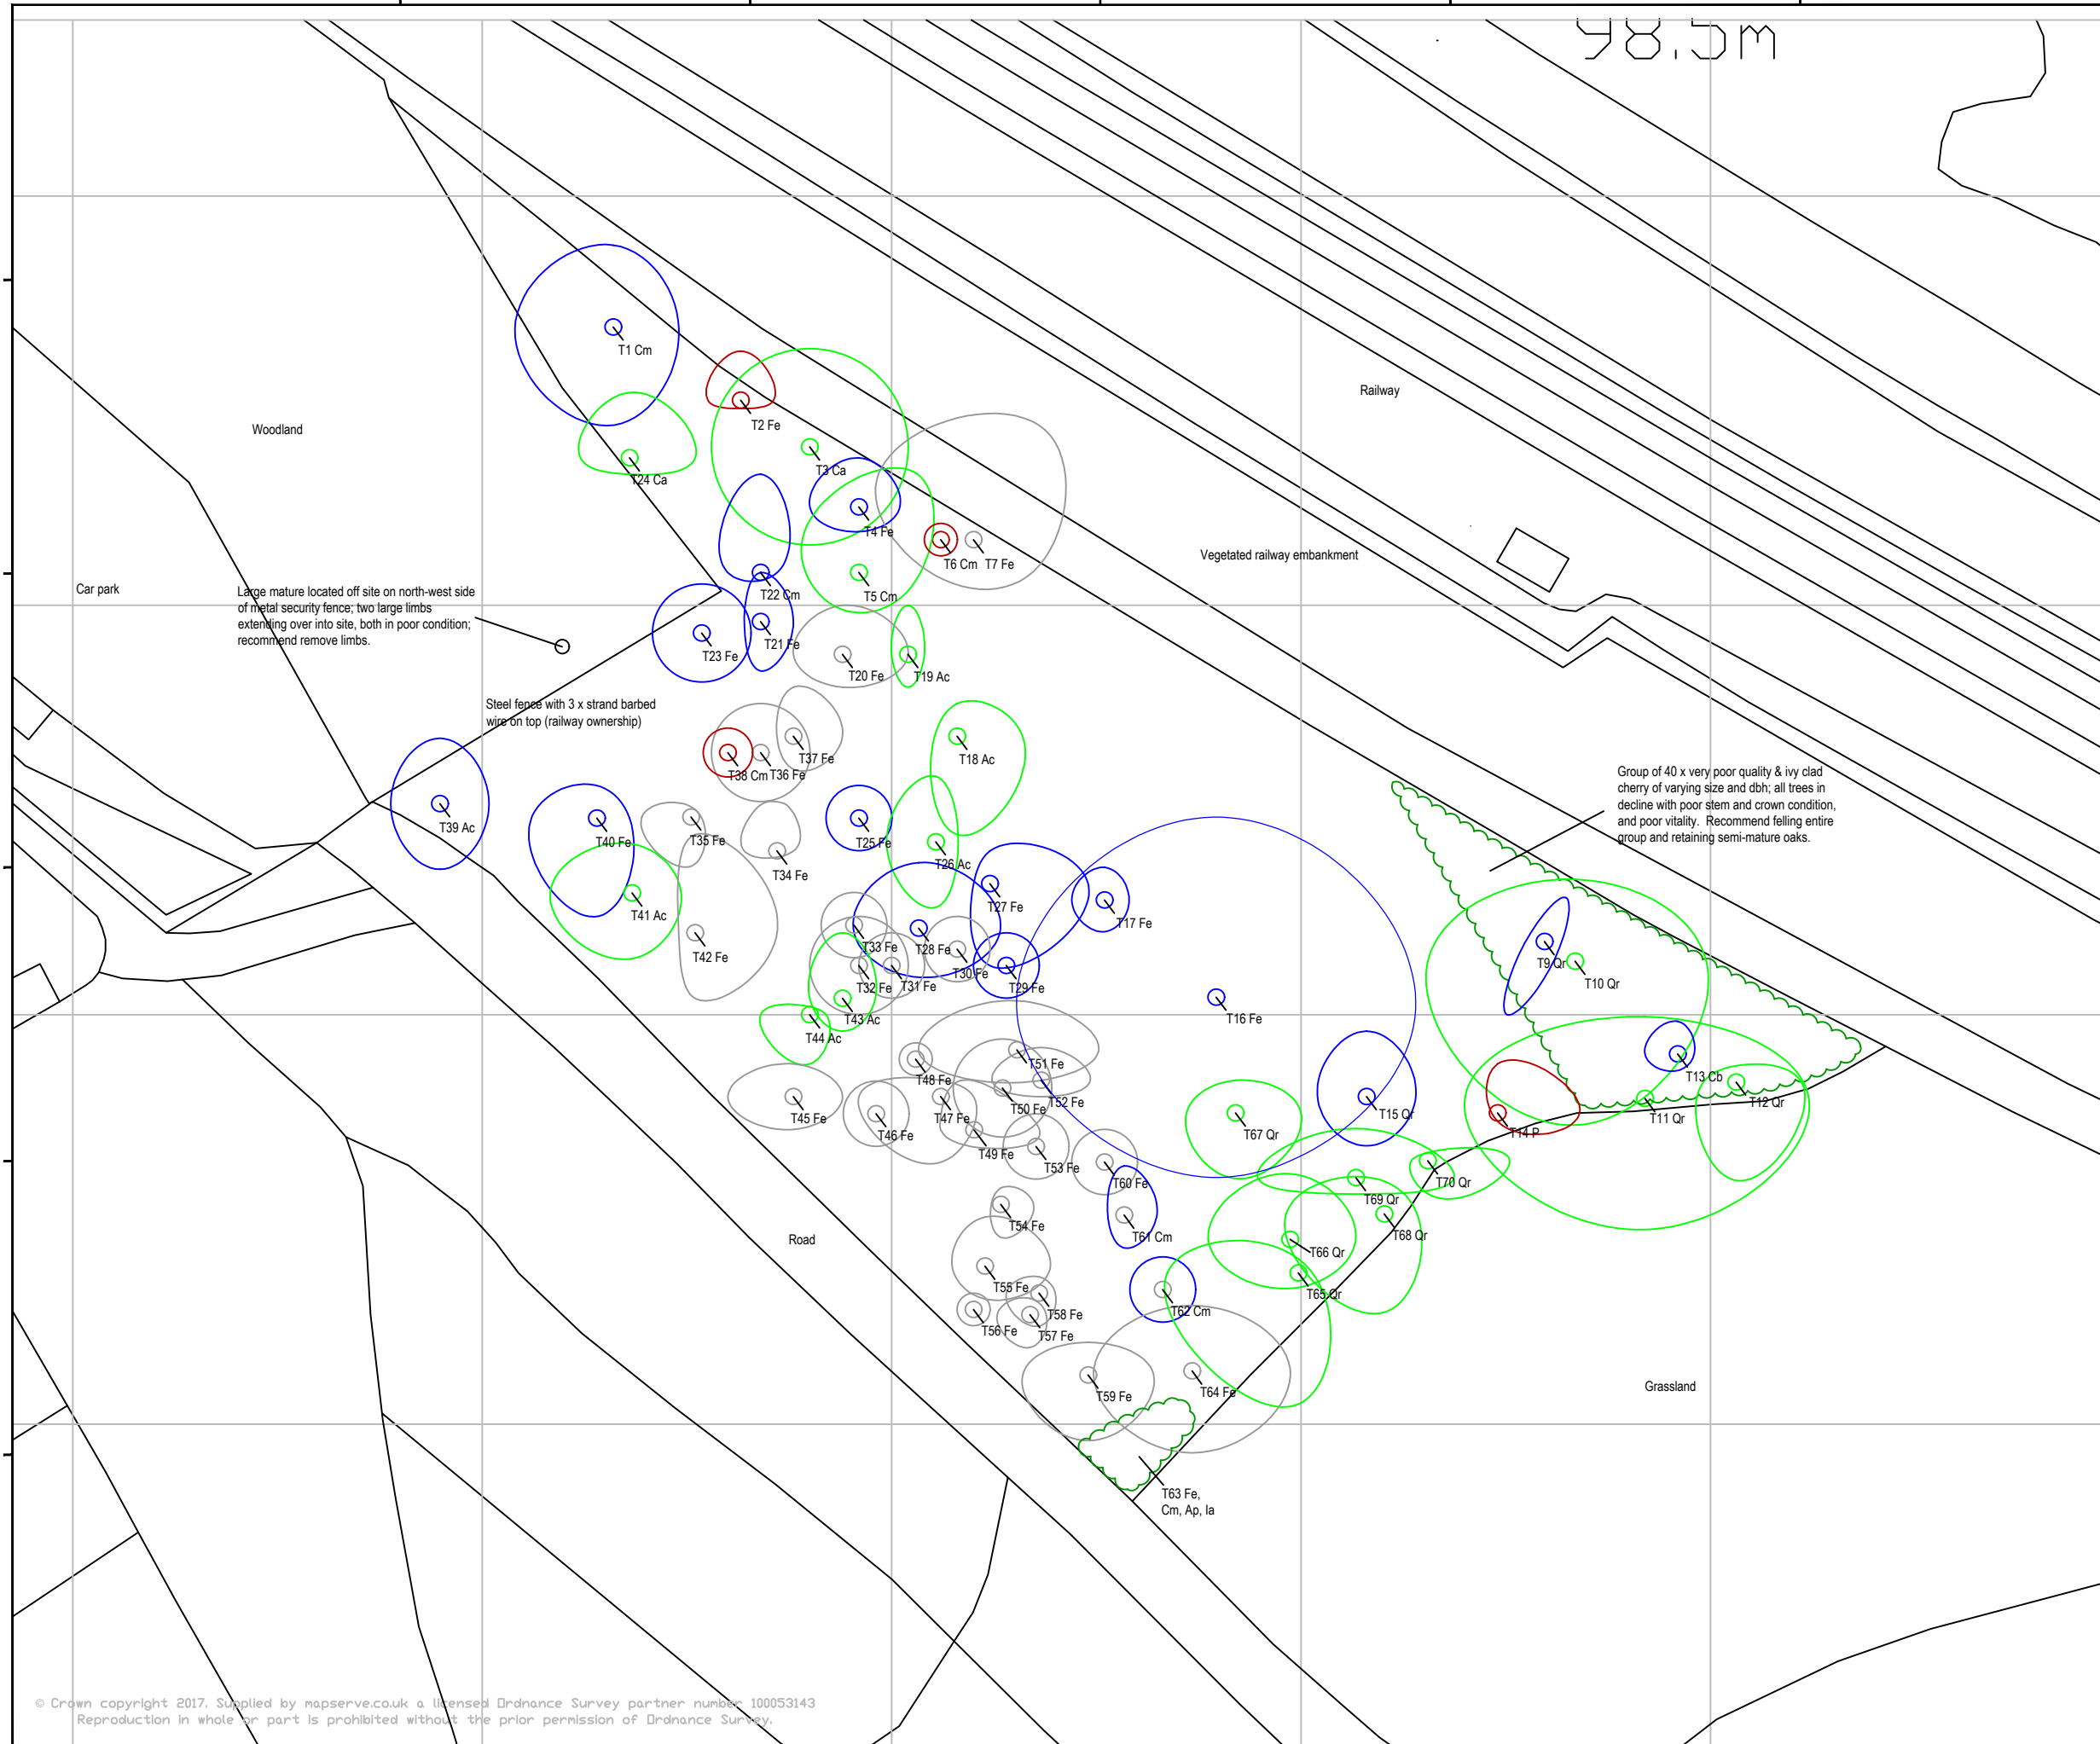
Large mature located off site on north-west side of metal security fence; two large limbs extending over into site, both in poor condition; recommend remove limbs.

Group of 40 x very poor quality & ivy clad cherry of varying size and dbh; all trees in decline with poor stem and crown condition, and poor vitality. Recommend felling entire group and retaining semi-mature oaks.
